**Kuruthukuli Model Watershed  
Nilgiris District  
Tamil Nadu**

**ICAR-Indian Institute of Soil & Water Conservation (IISWC)  
Ree's Corner, P.O. Fernhill, Udhamandalam  
The Nilgiris-643 004, Tamil Nadu**

# **Kuruthukuli Model Watershed Nilgiris District Tamil Nadu**

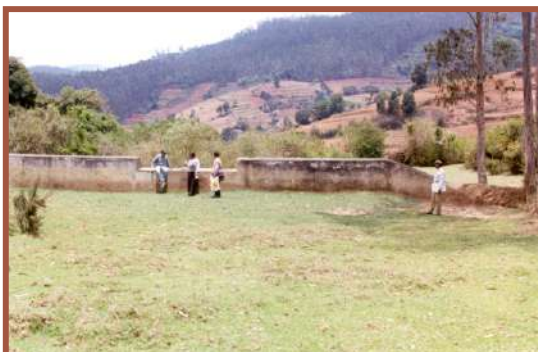
**Silted up check dam before project intervention at Kavakadu**

- Integrated nutrient management practices were demonstrated for potato crop at the site of the renovated bench terraces. A silted up check dam in Kavakadu sub-watershed was desilted and earthen side bunds were formed on either side to create a storage capacity of about 500 m<sup>3</sup>.

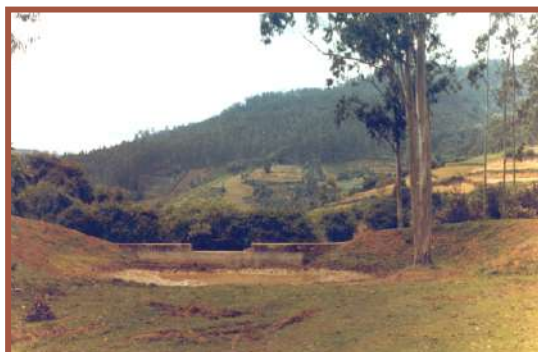
**Desilted check dam with side earthen bunds at Kavakadu**

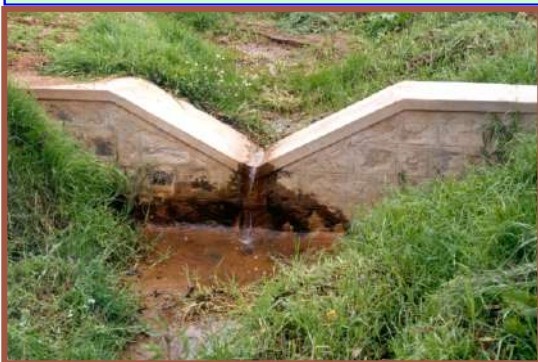
**Triangular weir at Iv<sup>th</sup> nested point**

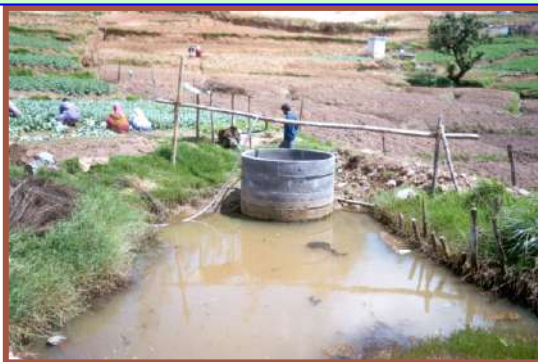
**Collection well installed at Kavakadu**

- Three collection wells (2m diameter and 5.2m deep) were installed in KG-4-1 watershed for harnessing the subsurface flow.
- Tea clones were planted on the risers of the renovated terraces in an area of about 0.5 ha in KG-4-1 watershed.

- Eight collection wells with a total capacity of 128 m<sup>3</sup> were installed in KG-4-1 watershed for subsurface harvesting. Two water harvesting check dams were also constructed with a water storing capacity of about 90 m<sup>3</sup> each. One gabion checkdam was constructed in the main stream of Kavakadu sub-watershed (33 ha), where there was sudden drop of 3 m.

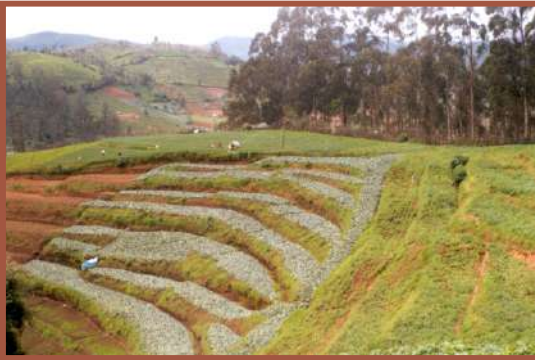
**Cabbage crop cultivated in terraces renovated during 2002, Kavakadu watershed**

- In a 33 ha sub-watershed situated at Kavakadu (KG-4-1 watershed), renovation of bench terraces was carried out in an area of about 1.5 acres. In addition to this, outward sloping terraces were also renovated in 7 ha of land. New bench terraces had been formed in an area of about 0.6 ha in a critically erosion prone site in the sub-watershed.

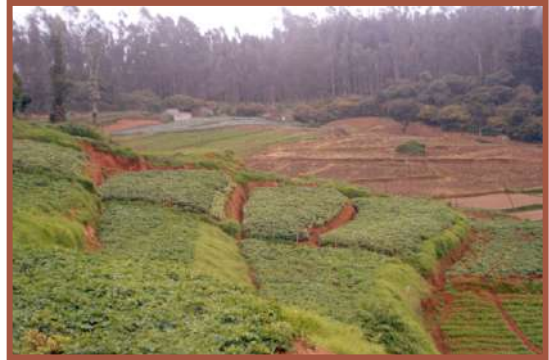
**Potato crop cultivated in renovated terraces , Kavakadu watershed**
