**Salaiyur Model Watershed  
Coimbatore District  
Tamil Nadu**

# Salaiyur Model Watershed Coimbatore District Tamil Nadu

The ICAR-IISWC, Research Centre, Udhagamandalam, Chennai took up Kuruthukuli (KG-4-1) Salaiyur watershed in Avinashi Tehsil, District Coimbatore, Tamil Nadu during 1997 to 2003 covering three villages viz Onnakarasampalayam, Kurumbapalayam and Salaiyur. The watershed has 513 area with 602mm average rainfall. The major problems identified in the watershed are lack of water resources, low rainfall, ground water depletion, rapid runoff, gravelly & light red soils prone to erosion, poor vegetative ground cover, rainfed agriculture in major area, shallow soil depth, soils having low water holding capacity & low nutrient status. Significant part of population was landless labourers. Various entry point activities like community hall construction, distribution of iron ploughs, ceiling fans and steel bench to the primary school and hand pump on community land were carried out to built rapport with the residents in the watershed. Six check dams were constructed for stabilization of gullies along with vegetative measures under soil and water conservation interventions.

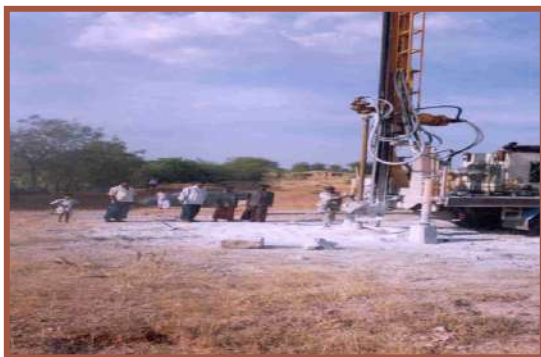
**Boring for installing hand pump**

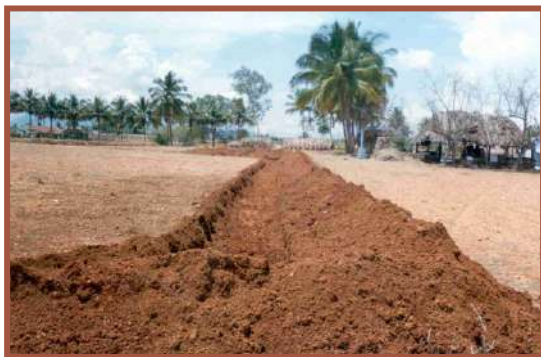
**Field bunding**

**Field bunding:** Field bunding on individual farmers' fields was taken up in an area of about 30 ha covering about 5000 running meters.

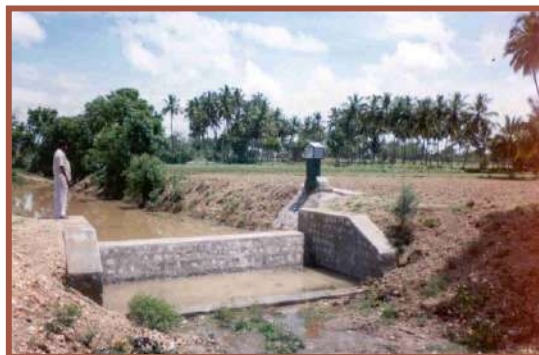
**Check dams**

**Check dams & Percolation ponds:** Six check dams were constructed for stabilization of gullies along with vegetative measures. Rejuvenation of 5 percolation ponds (3 on private land and 2 on community land) was completed by desilting and reshaping of ponds to

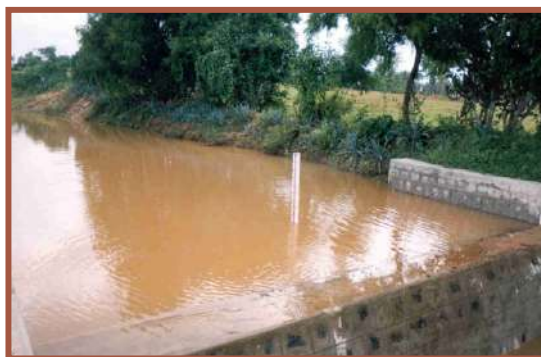
**Percolation pond**

increase their capacity along with repair of spillways. Five new percolation ponds were constructed on community as well as on private lands. In addition, two new percolation ponds were constructed through State Agricultural Engineering Department in the watershed as an example of convergence of development schemes in the watershed. In all, a total storage capacity of 266 ha-cm was created in the watershed for water harvesting and augmenting groundwater recharge.

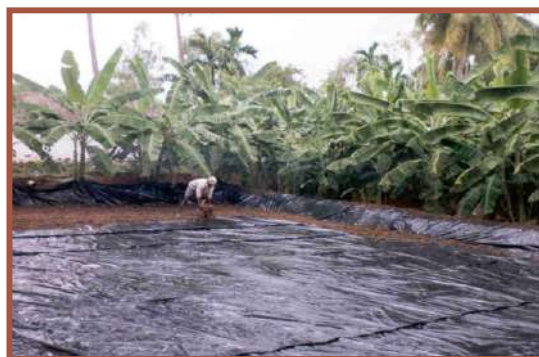
**Lining of shallow water storage pond  
with HDPE sheet**

**Water conservation through HDPE lining:** Lining of ponds with HDPE sheet was demonstrated at three ponds to cut down seepage losses. Average size of a pond was 21m × 12m × 0.6m.

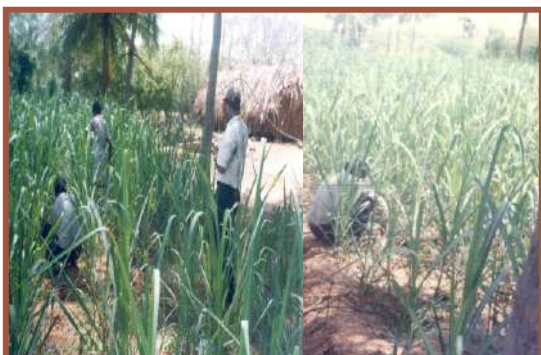
**Sugarcane field with drip irrigation for  
efficient use of water**

**Water management through Drip irrigation:** Drip irrigation was introduced for the first time in the watershed for efficient utilization of harvested rainwater.

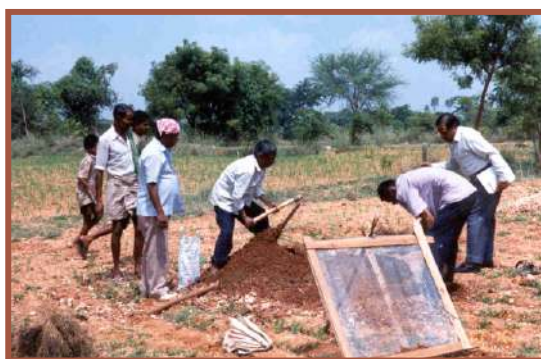
**Sieving of gravels for improving micro site condition**

**Diversification to Horticulture:** Horticulture plantation as a pure crop or in agri-horti system was taken up in an area of 31.88 ha covering marginal/degraded lands with shallow gravelly soils falling under LCC IV and VI. Mango and Tamarind were planted in an area of 11.88 ha and 20.00 ha, respectively, mostly on private lands under rainfed condition with moisture conservation practices. Besides this, aonla, pomegranate, guava and sapota were introduced. Improved varieties of coconut grafts were also distributed to the farmers and landless people to raise them near their agricultural fields and houses. Improved micro site condition for soil working and planting by adopting 1 cum pit size,

back filling pit with gravel free soil mixed with pond silt and FYM, live mulch *etc.*, were demonstrated to a set of farmers in their fields. Most of the farmers in the watershed adopted improved practice of pitting and planting.

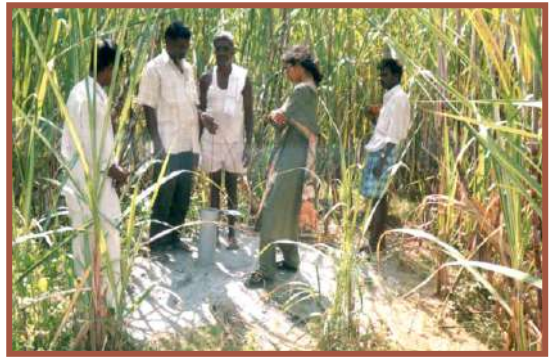
**Piezometric wells for monitoring ground water recharge**

**Instrumentation for Hydrological monitoring:** Three gauging stations were installed by fixing stage level recorders at three locations viz., two check dams, one percolation pond (Thopukuttai) and one at the outlet of the watershed to measure the runoff at three different points. For monitoring ground water levels, certain number of observation wells (dug wells) were identified besides installation of eleven piezometers in the influence zone of selected percolation ponds.

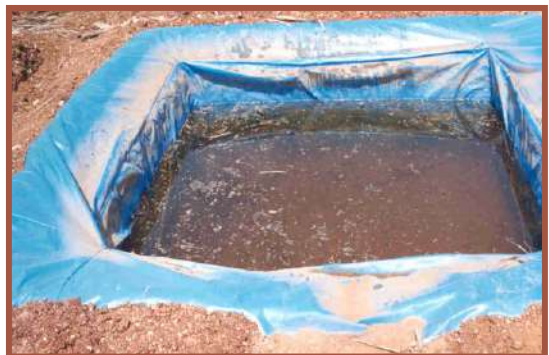
**Lined runoff collection pit**

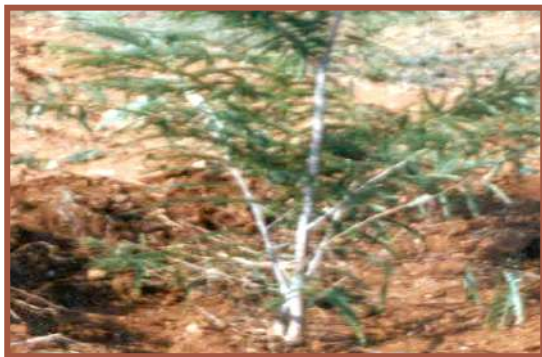
**Pitcher Irrigation**

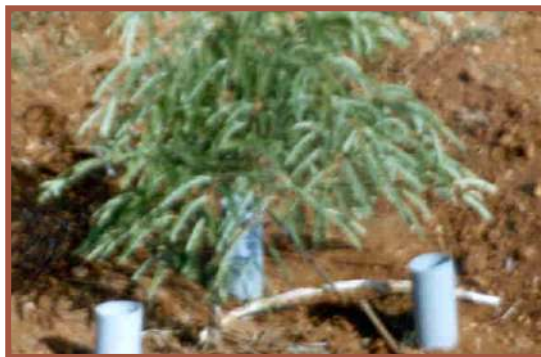
**Watering through PVC pipes**

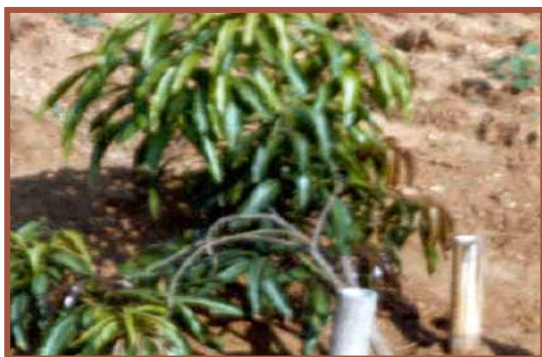
**Watering through Bamboo poles**
